1.0 Executive Summary

In Estes Park, the **Fish Creek Corridor Plan for Resiliency** is the fruition of this directive and the first step in a decades-long journey of recovery and preparedness. The Plan is both a technical reference serving as a basis for final design, construction, and monitoring as well as a funding tool to support the grant writing process for flood recovery implementation funding.

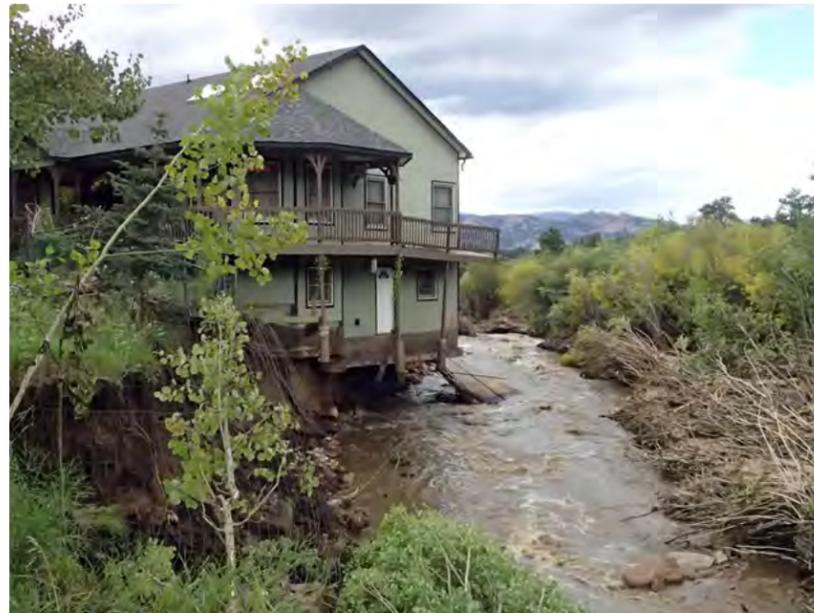
Fish Creek Whispering Pines Dr. Home Damage

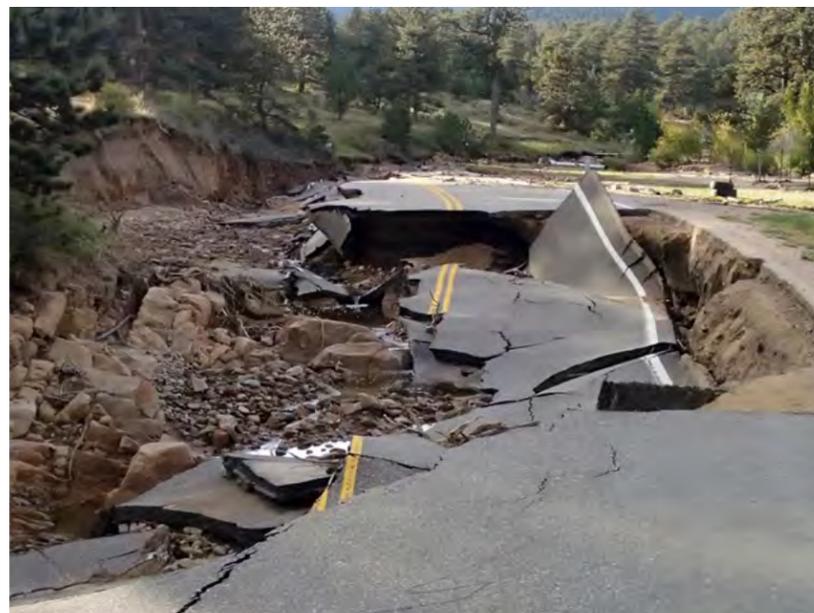
Fish Creek Road Damage
